PATCHY OR DULL RESULTS ?

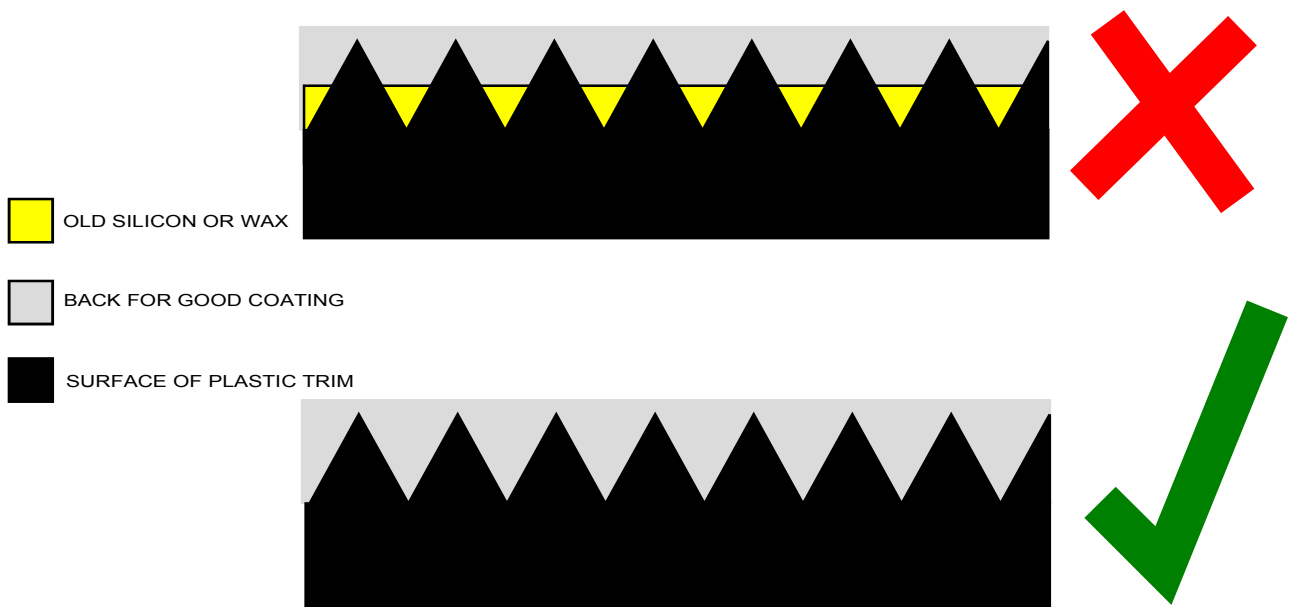
BACK for GOOD needs to make contact with the plastic to react and treat the problem. If All the old waxes and silicon's are not fully removed before the coating is applied then the **BACK for GOOD** is unable to make contact with the plastic (See illustration below) and the resultant finish looks either patchy or cloudy.
